## MANUAL TO PREVENT SHRINKAGE IN SPHEROIDAL CASTING

This manual is based on Fumbarri's research and experience, with the collaboration of its Clients and Suppliers, and using information from Metallurgical Technological Centres to improve its product and minimise defects.

It has historically been common, during the machining of geometry parts, mortices, holes or housings in spheroidal casting parts (GGG or JS), for porosities of one size or another (macro or micro-shrinkage holes) to appear. So Fumbarri has drawn up this manual to find out the causes behind shrinkages and to minimise their appearance inside parts, by correctly defining the geometries of the parts in the design stage or during the patterns' manufacture.

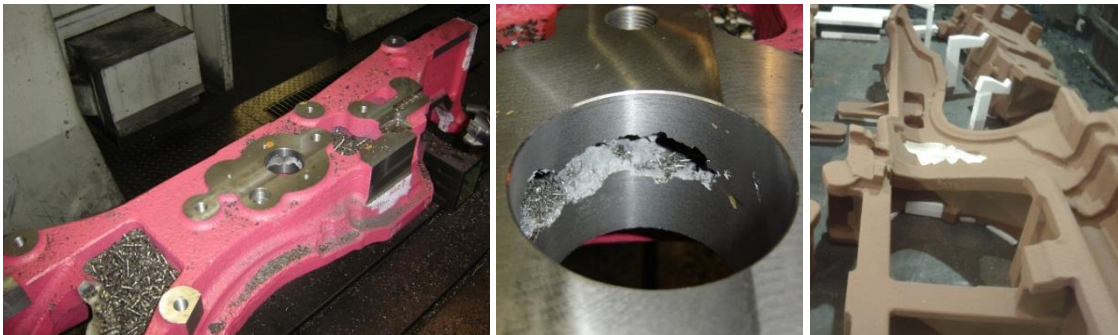
- Shrinkage in housing for the piston guide bushing

In these patterns, the holes for the housing of the guide bushings were not made.

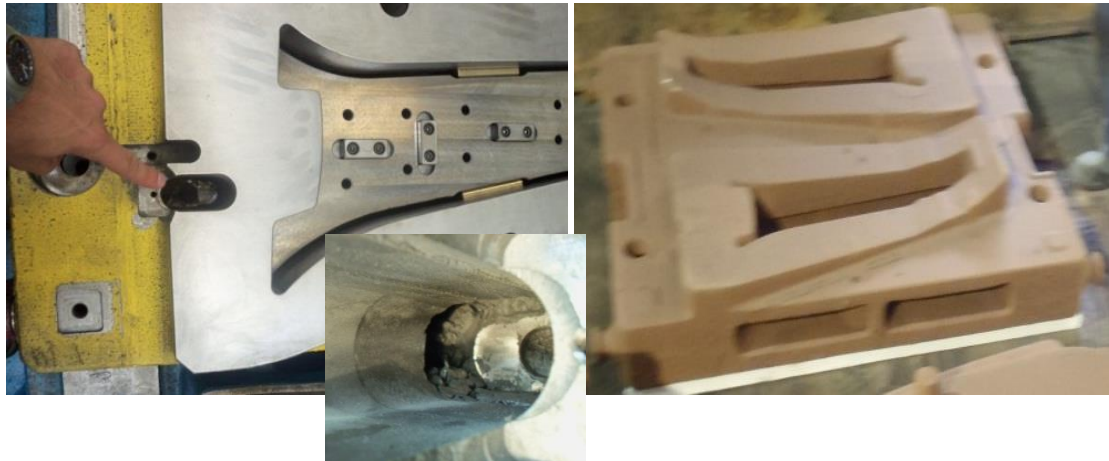
- Shrinkage at the bottom of the mortice to release the sheet metal detection device

The release mechanisms were not completed in the pattern for the sheet metal detection devices or for the centring mechanisms.

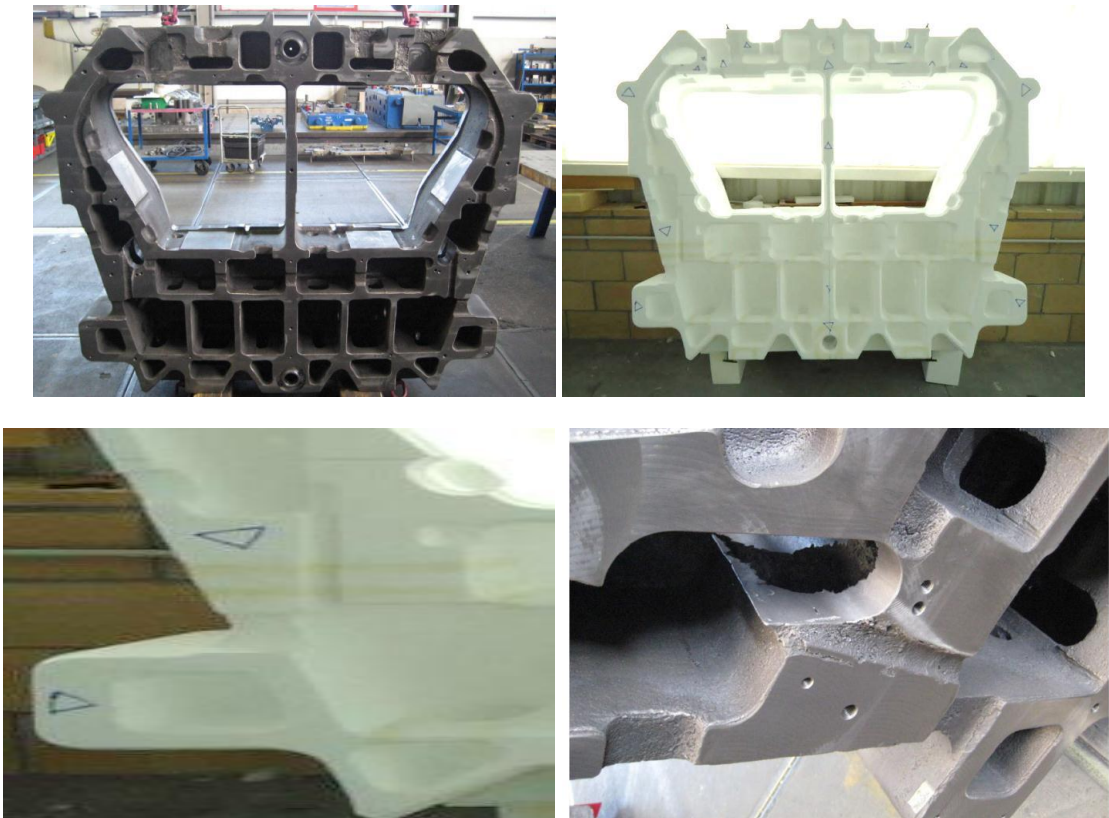
- Shrinkage in the release mechanisms for the passing of turrets in the piston

The release mechanisms for the passing of turrets were not completed in the pattern, generating a huge mass.

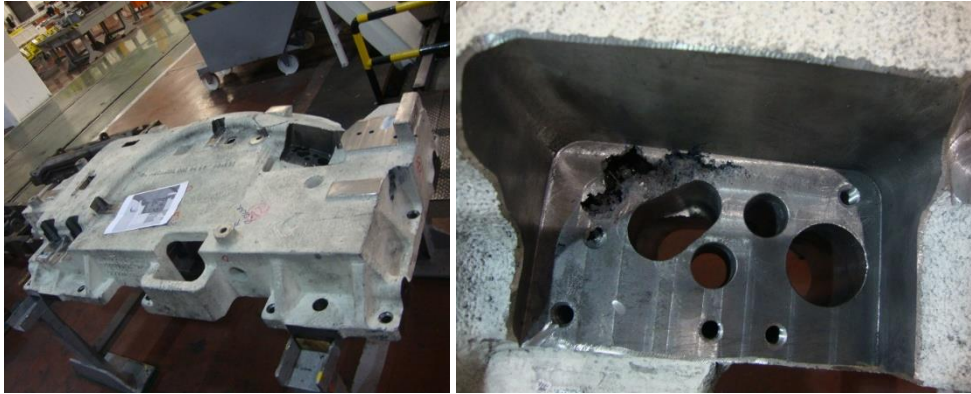
- Shrinkage in the release mechanisms for the passing of turrets in the piston

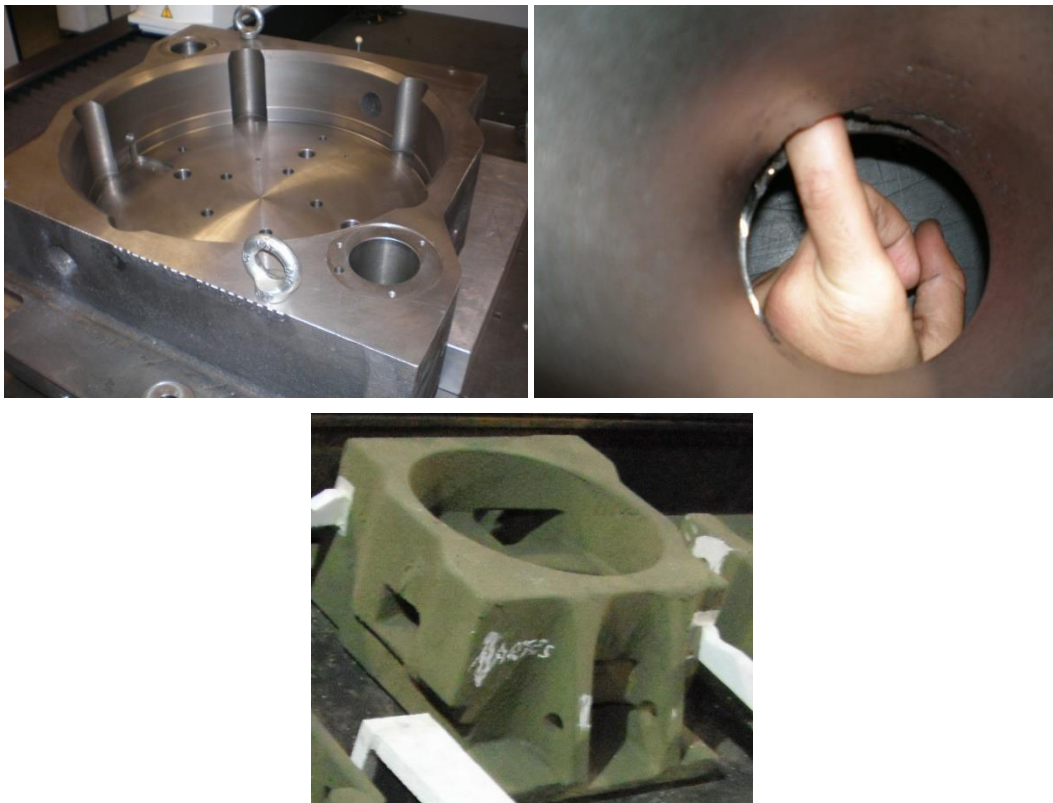
- Shrinkage in holes for column housing

When the mortice is machined, shrinkage appears.

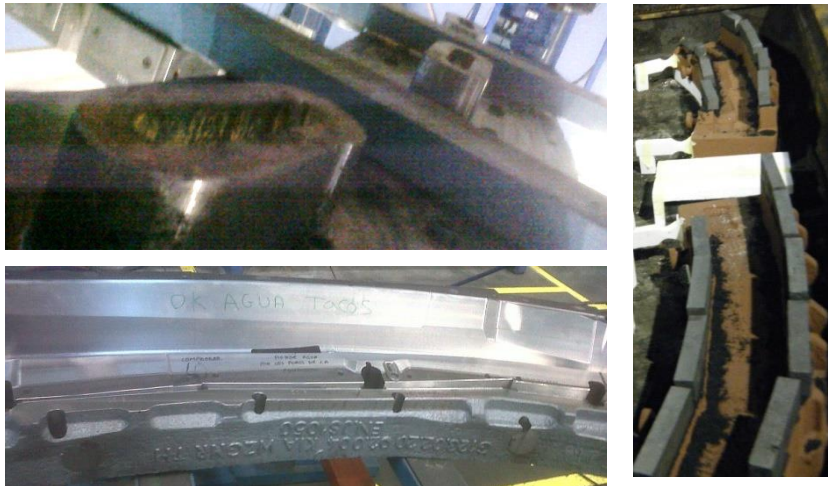
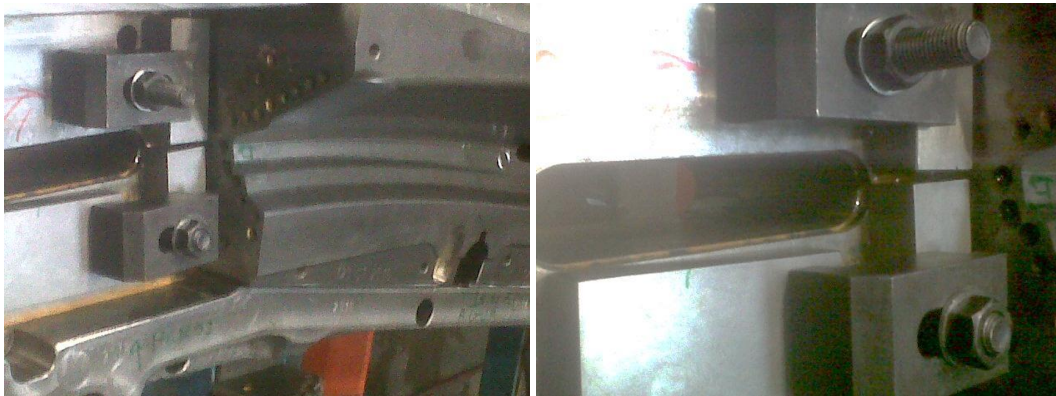
- Shrinkages in the water collectors of the hot stamping mould

When water pressure is introduced, the water leaks through the collector in the slots where the water passes through, due to the fact that there were shrinkages because the slots were closed in the patterns, generating isolated masses where the shrinkages are located.

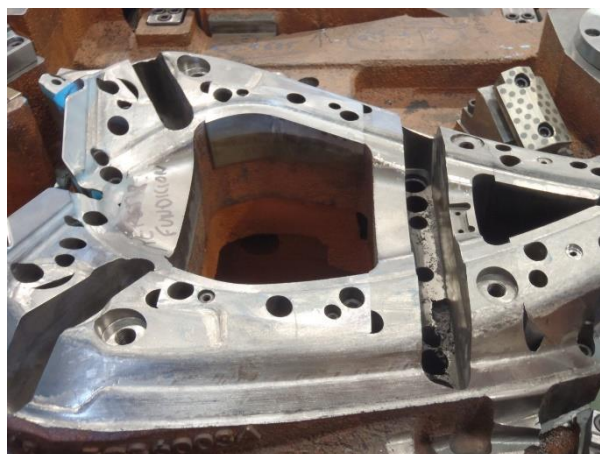
- Shrinkages in lift housing

When machining the mortice for the lift housing, shrinkages are detected. If this mortice had been carried out in the pattern, the defect would not have appeared.

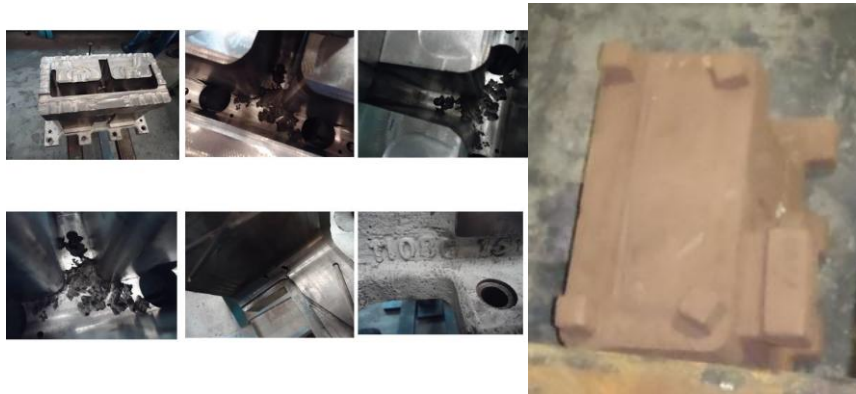
- Shrinkages at the bottom of the mortices

When machining the release mechanisms, shrinkages appear at the bottom of the mortices. The defect is due to the fact that the core pattern was manufactured without mortices.

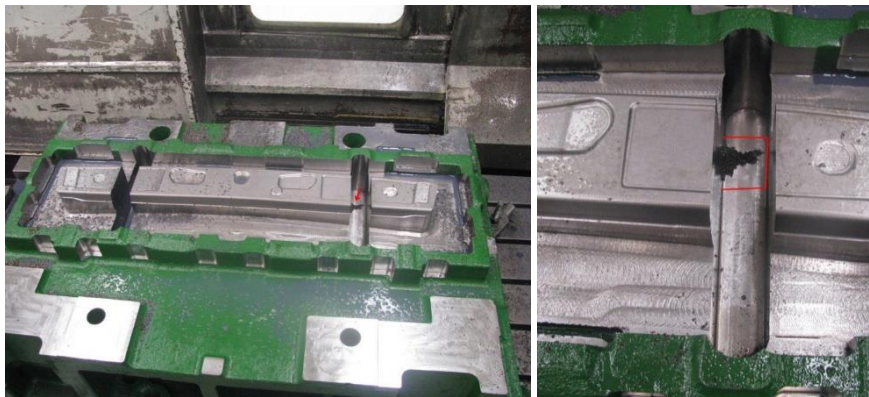
- Shrinkages at the bottom of the lift housing.

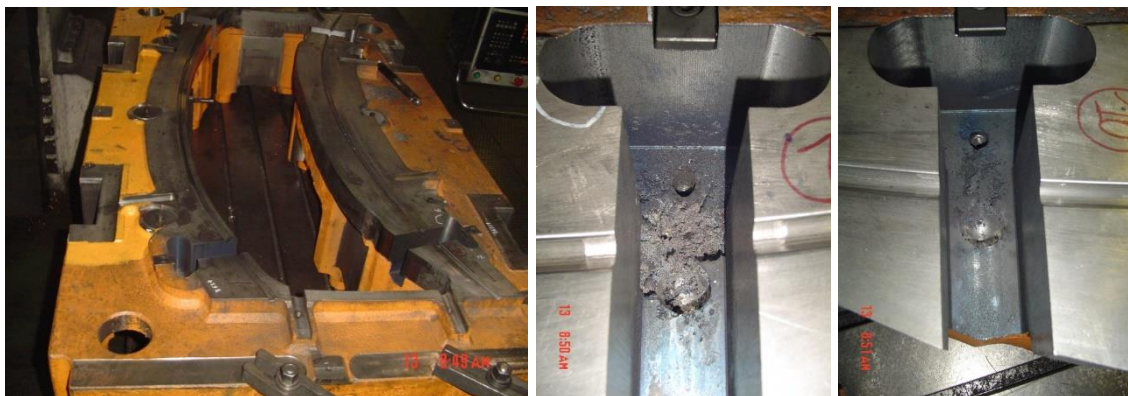
- Shrinkages in the mortices and the lift guide holes

Very common defect. When machining the lift housing, shrinkages appear at the bottom of the mortices. This is due to the fact that the pattern did not have the mortices for the lift housing.

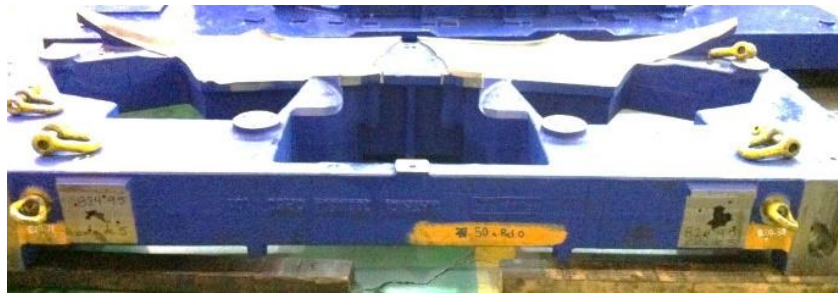
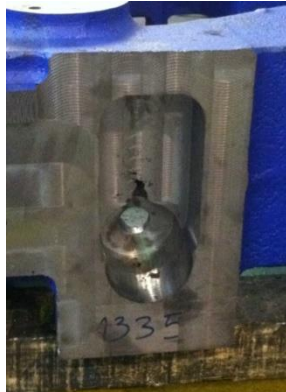
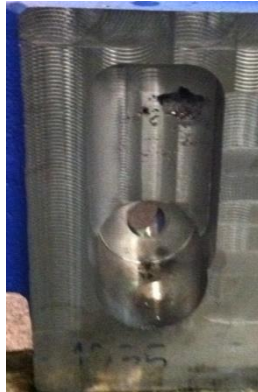
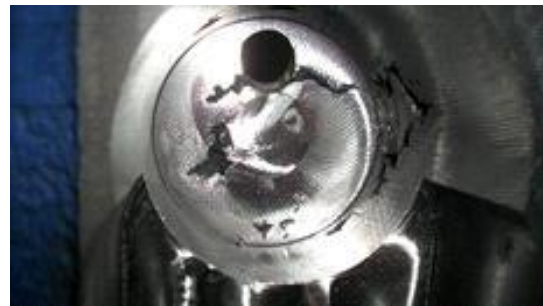
- Shrinkages in the limit mortices and in the seat for the piston guide strip

When machining the mortices and holes for the limitation rubber, shrinkages have appeared. The defect is due to the fact that the piston pattern was manufactured without mortices. Shrinkages have also appeared on the seats for the guide strips, which are due to the fact that, on those areas, the pattern had the previous handling eyebolts still in place, and when the part was machined, shrinkages appeared.

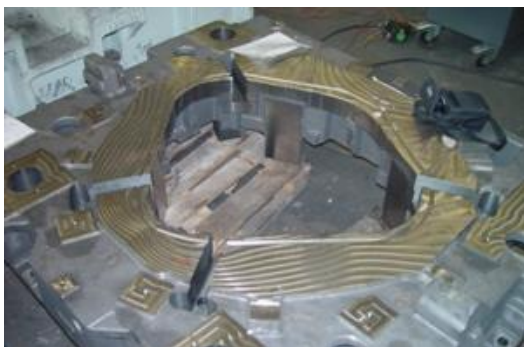
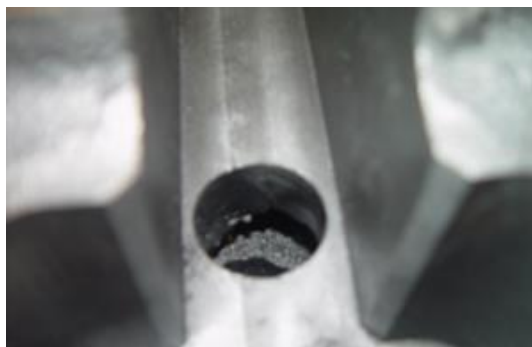
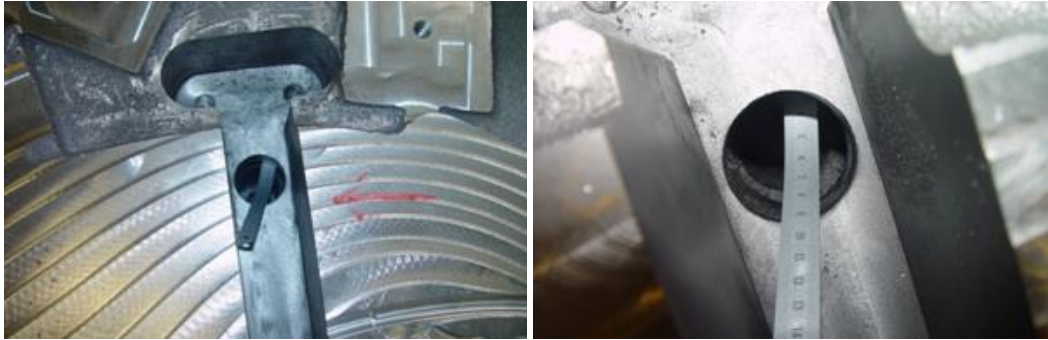
- Shrinkages in the mortices and the lift guide holes

Very common defect. When machining the mortices and holes for the lift housing and guide, shrinkages appeared at the bottom of the mortices and inside the holes. This is due to the fact that the pattern did not have the mortices for the lift housing.

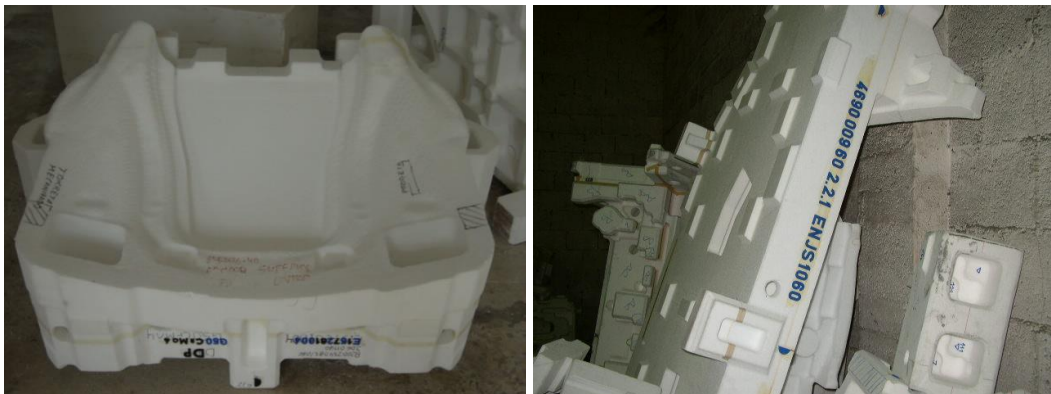
Occasionally, the eyebolts or plates are inappropriately placed for the job in question, generating hot spots that can cause shrinkages and which prevent coolers from being put in place.

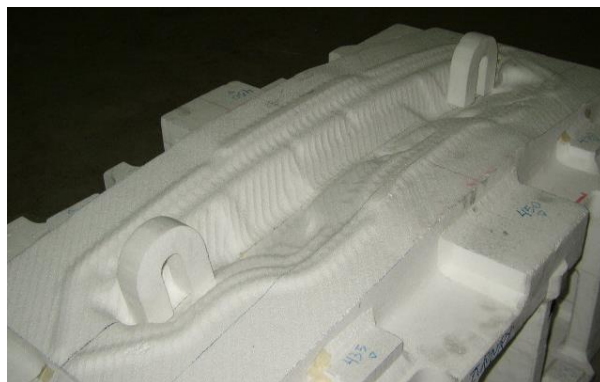
This problem arises with the support blocks in the first phase of machining or with the test specimens placed in the copy zone, so we recommend you follow the same criteria as indicated above.
