## DEFECTS

### Index

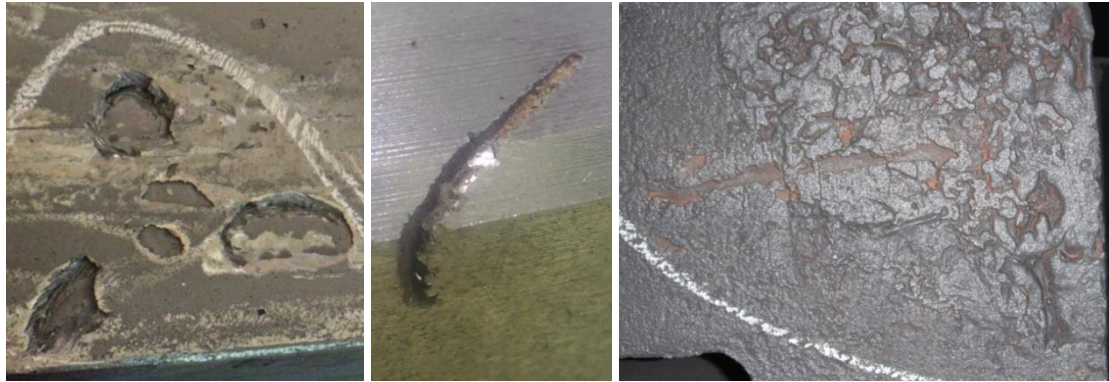
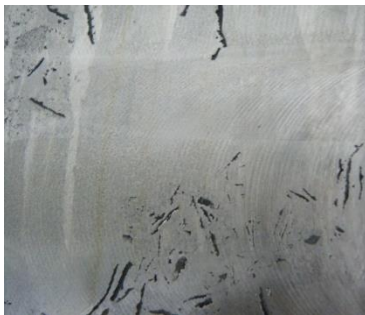
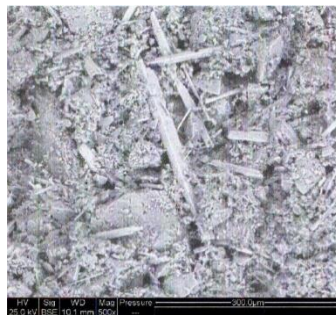
### 3. Paint Inclusion

- These inclusions come from detachment of the refractory paint with which we paint the lost form patterns, dragged by the pouring mixture towards the upper part of the casting.
- There are discontinuities in a flat form that appear at the cavities of the upper parts of the piece (in casting position). The size depends on the detached amount paint.
- While machining them, paint inclusion is linear, sandy with dark colour y get attached to superficial parts of the casting. They usually appear together with sand inclusions.
- While machining can cause abrasion of the machining tool.

- Low mechanical properties of the mould.
- Penetration of the paint into the mould due to the separations at the mould unions.
- Calcinations, due to a low siliceous sand compactability.
- Pattern with wet paint and/or accumulations of paint not properly attached.
- Paint with low attachment properties.

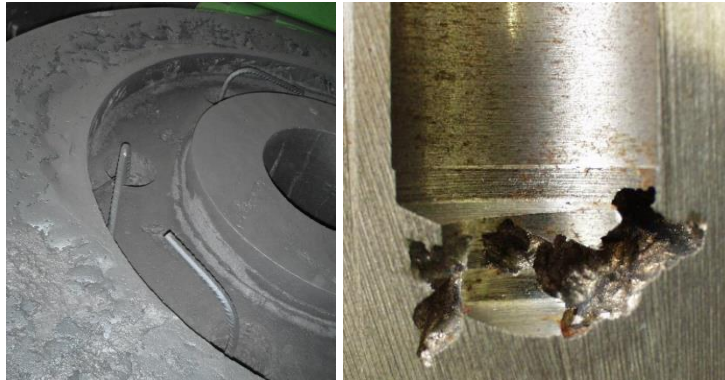
## 5. Primary Shrinkage

- It appears like open cavities or closed to the exterior, the surface is usually flat, and occurs in last solidifying areas.
- It can also be present like a depression or and sinking at the external surface of the mould, sometimes not being a cavity.

- The primary shrinkage is produced due to the liquid contraction occurring at the metal from melting to the final solidification.
- Lower the Equivalent Carbon (Ceq), higher the metal contraction and consequently higher shrinkage tendency.
- With a higher melting point, more time the metal is contracting and consequently more time for the shrinkage to from.
- Inadequate filling system and/or alimentation system.
- Hot spots resulting from wrongly designed entrances.
- Low mechanical properties of the mould, causing a mould dilatation.
- Lack of size and chiller position.
- High liquidus temperature, depending on the Ceq position.
- Insufficient, poor or low inoculation.
- High residual magnesium.

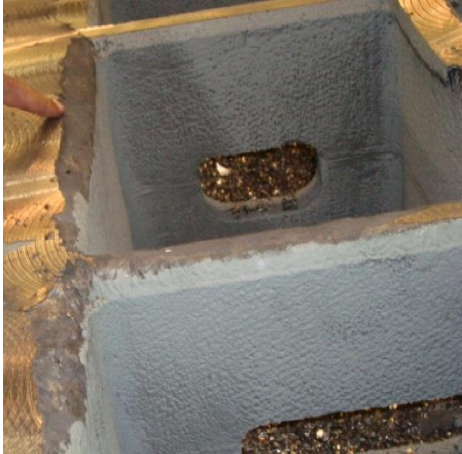
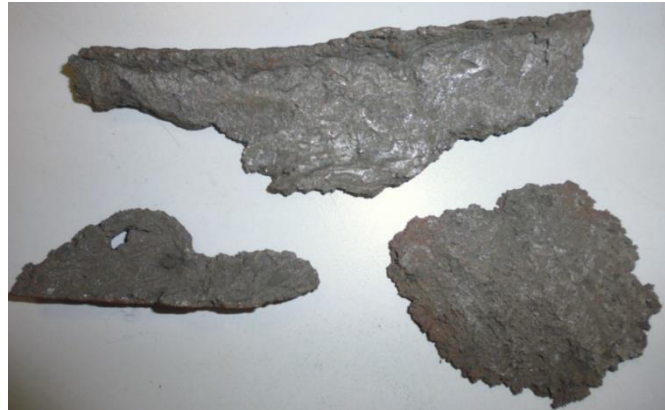
## 10. Lustrous Carbon Inclusion

- Presence of filling marks, inclusions and / or metal separations due to a impermeable carbon film or flakes which gets attached onto the surfaces of the part.
- The defect's surface shows a curved and shiny finish, appearing a bright carbon film deposited on the metal.
- In some cases, separation of metal and / or internal inclusions is formed because of turbulences or liquid metal heavy flows transporting lustrous carbon flakes.
- Usually, the defect is located on top of the parts (casting position) and in areas affected by high turbulence.
- In case of spheroidal casting, they appear together with oxidation and slag inclusions.
- Lustrous carbon inclusions are formed at temperatures above 650 ° C, causing a film left on the silica grains.

- The excess of materials capable to generate lustrous carbon (styrene, refractory painting) in the sand allows this material to be deposited even before the metal completely fills the mould cavities (green moulding).
- Filling systems which promote turbulence filling regimes.
- Excessive filling times.
- Low casting temperatures and / or use of very long casting channels (temperature losses in the metal).
- Low permeability in moulds and / or punches.
- Insufficient gas exits in moulds and/or punches.
- Metal turbulences change the position of the deposited carbon sheets, creating creases which may appear on the surface of the defect.

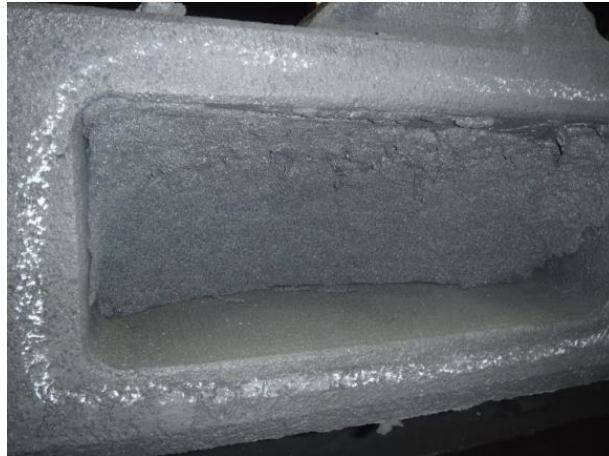
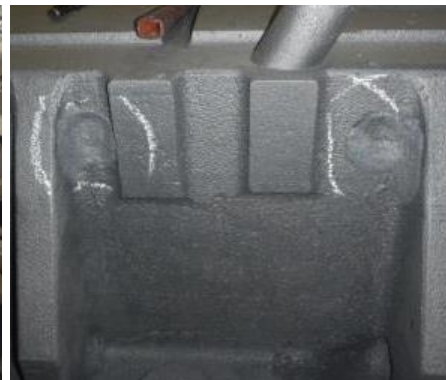
### 13. Calcination

- Calcinations are sand firmly added to the casting surface. The melted metal has penetrated the sand, recovering the grains and forming an adherent crust.
- Calcinations appear with more frequency at the metal entrances, hot spots, and massive areas.
- Normally, calcinations originate from sand dragging and sand/paint inclusions.
- If not completely removed while deburring, they may produce abrasion to the machining tool.

- Lack of refraction of the paint, used to paint pattern or mould.
- Sand humidity.
- Low mould refraction, produced by: Poor furanic resin (Low furfurilic alcohol content), Low resin content on the mixture sand-resin, High water content at the sand-resin mixture, Too big sand grains, High sand temperature on mixture, Low sintering point at the sand...
- High melted iron temperature.
- Lack of mould compactability.

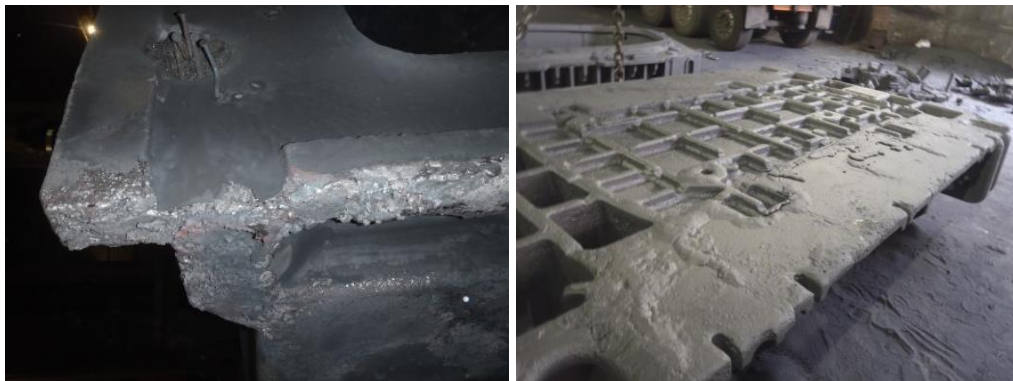
## 14. Mould Not Filled

- When the mould does not get completely filled, the result while demoulding is a lack of material on the upper side of the casting as in the casting position (bottom of the part). Generally, the surface with lack of material has rounded forms and cold unions.
- The part not completely filled are internally dismissed and replaced.

- The pattern polystyrene has a lower density that the stipulated 20kg/m<sup>3</sup>, originating while doing the charge prediction, that this is not enough.
- Wrong weight of the melting crane weighing.

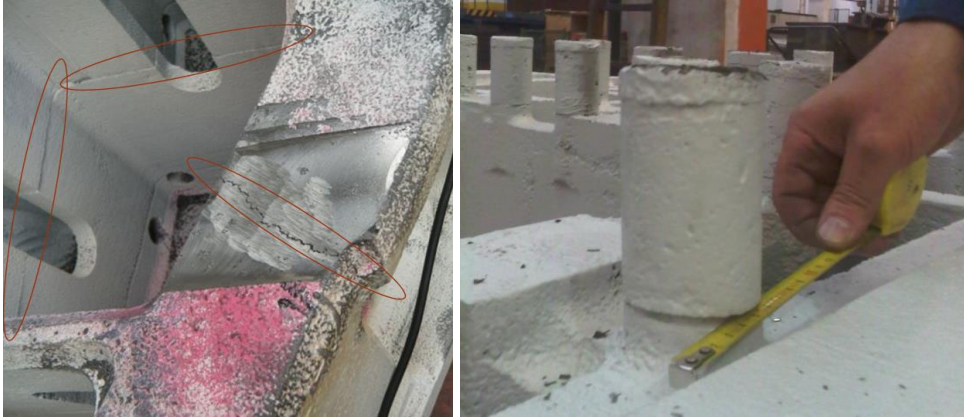
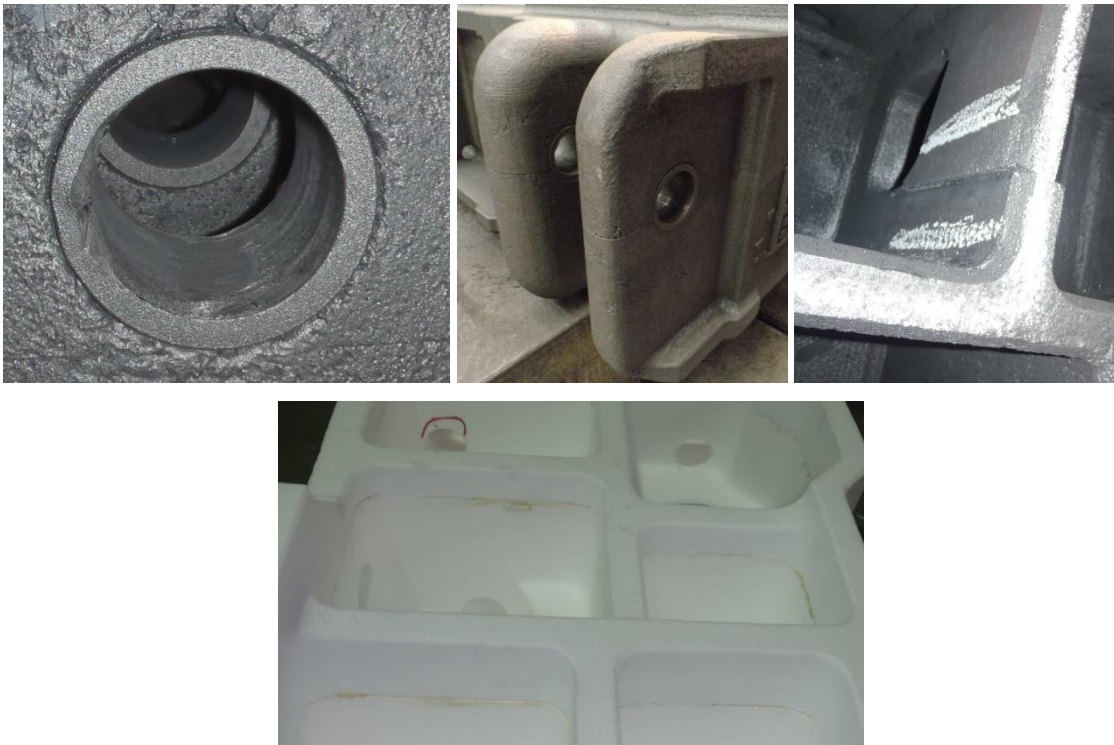
## 15. Cracks, Traces and Discontinuities at Polystyrene Pattern Unions

- Linear discontinuities on the metal surface, the deep varies depending on the pattern separation and the refractory paint penetration.

- Gap between layer unions or pattern parts.
- Missing tape masking the union between layers.
- Gap between steel sleeves and lifting ear holes because insufficient glue and/or tape on junction.
